## CAN YOU IDENTIFY THE HAZARDS?

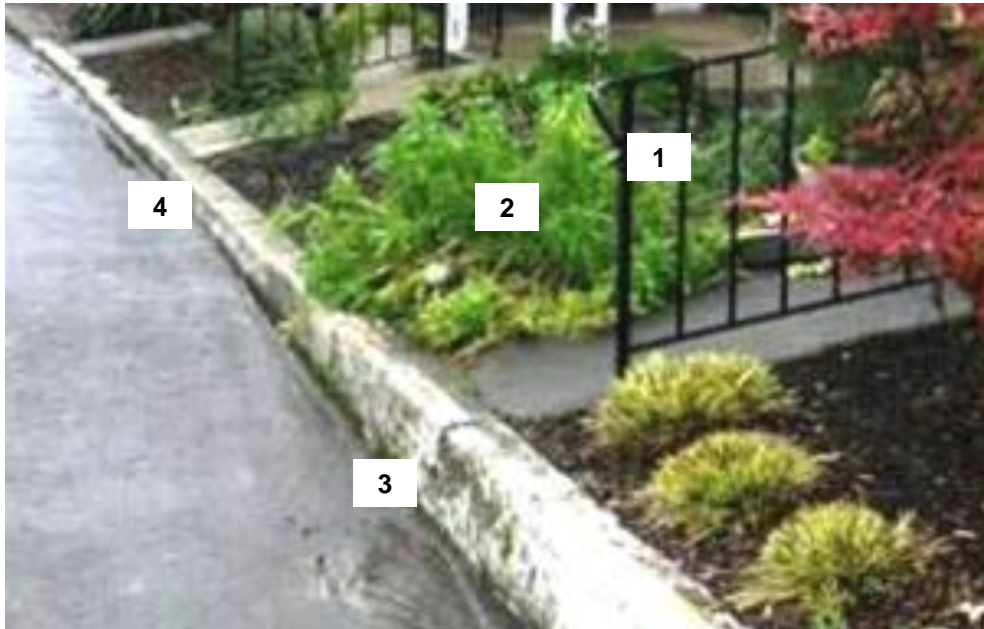
1. The handrail does not extend far enough. It should extend to the end of the walkway. In its current position, it would be a very long reach from the parking lot to sidewalk and vice versa.
2. The landscape plant is encroaching on the sidewalk walking surface, creating a slip, trip and fall hazard. Walkways should be kept clear and unobstructed, and the plant should be trimmed.
3. The curb is too high from the parking lot to the walkway, creating a trip and fall hazard. This distance should be shorter.
4. The curbing needs to be repainted. This will allow for easier identification to the users that a step up/step down hazard is present.
