## WATER DAMAGE PREVENTION: ICE DAMS

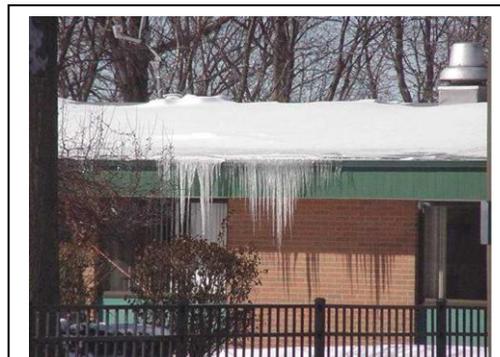
The formation of icicles is a good indicator that there is poor insulation/venting in the attic area. This can lead to water damage.

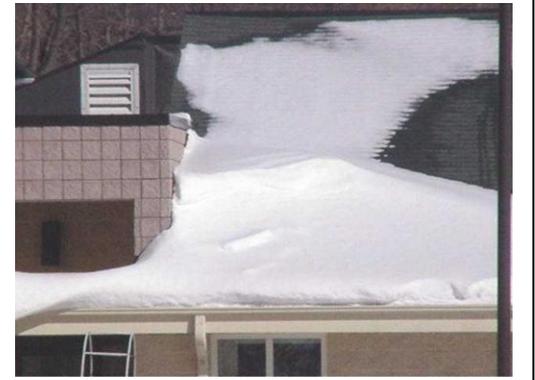
The heavy accumulation of snow on the roof could lead to the formation of an ice dam. Snow should be removed two to three feet from the roof edge.
