The Hidden Danger Lurking in Your Electrical Box

A Quick Check of Your Circuit Breaker Panel Can Shed New Light on Your Electrical Hazard Exposure

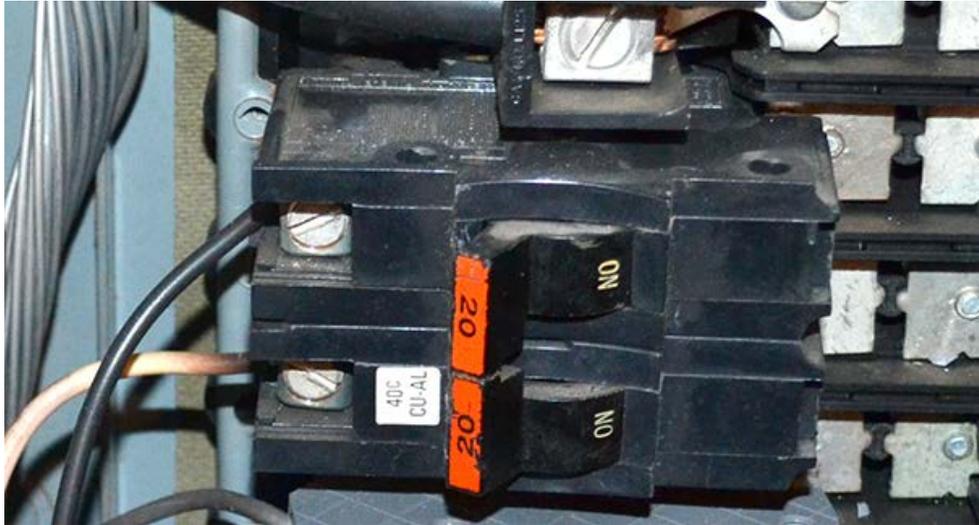
This is a close up view of a 20 ampere double-pole Stab-Lok breaker showing the handle shape and color.

Tests performed by the Consumer Product Safety Commission, and independent consulting engineers, concluded that certain *Stab-Lok* breakers do not trip according to requirements and in some cases can jam in the “on” position. This condition was most pronounced in the *Stab-Lok* two-pole version of the breakers.

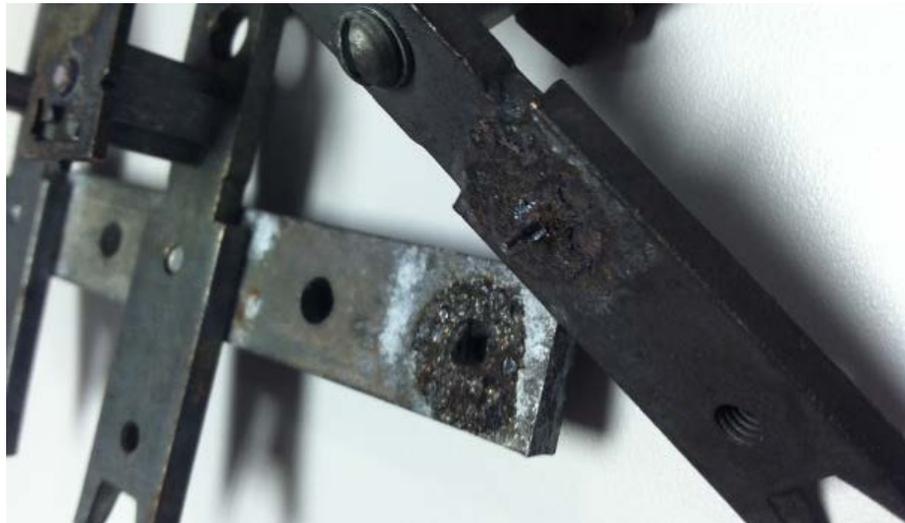
This is a failed, high-resistance, busbar connection inside a 200 ampere Stab-Lok panel. The arced-away steel screw holds the copper bar in the forefront to the aluminum bar in the background.

Based on these issues, when a Federal Pacific Electric *Stab-Lok* installation is discovered, the safest course of action is to replace it with a completely new panelboard and breaker installation.

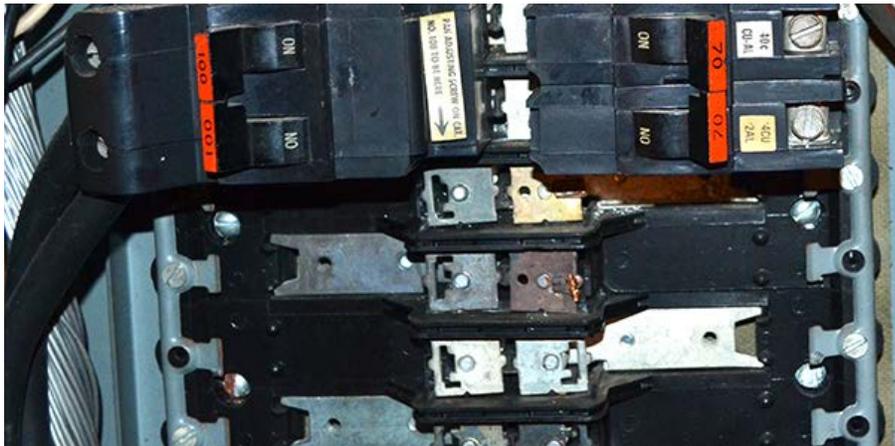
The dark-colored metal parts on the left side of the panel indicate overheating at points where the breakers connect to busbars. The light-colored metal parts on the right side of the panel appear to not have overheating discoloration.

A licensed electrical contractor should confirm whether Federal Pacific Electric *Stab-Lok* breakers and panelboards are currently in use.
