CAN YOU IDENTIFY THE HAZARDS?

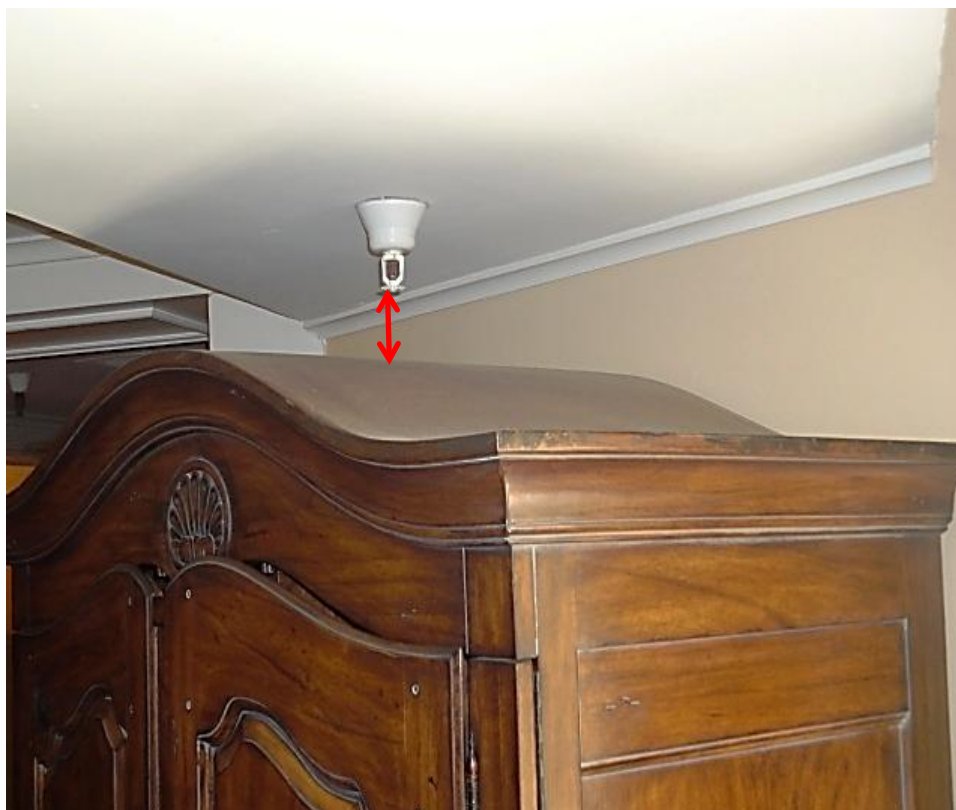
The sprinkler head protecting this apartment unit is being obstructed by a piece of tenant-owned furniture. To ensure a sprinkler head will disperse a proper water spray pattern under fire conditions, there must be at least an 18-inch vertical clearance between items being stored and any sprinkler heads.

This would include inside apartments, storage closets, maintenance rooms and food pantries. A standard safeguard to maintain this clearance in non-common areas is to draw a horizontal line around the room 18 inches from the bottom of the sprinkler head. Also a simple sign stating “no storage above this line” can be effective.
